## Maintenance Schedule

Schedule to be carried out three months after installation and annually thereafter. Please refer to the maintenance points. Complete the Container Dome column if you have purchased a Container Dome. Complete the Container Shed column if you have purchased a Container Shed.

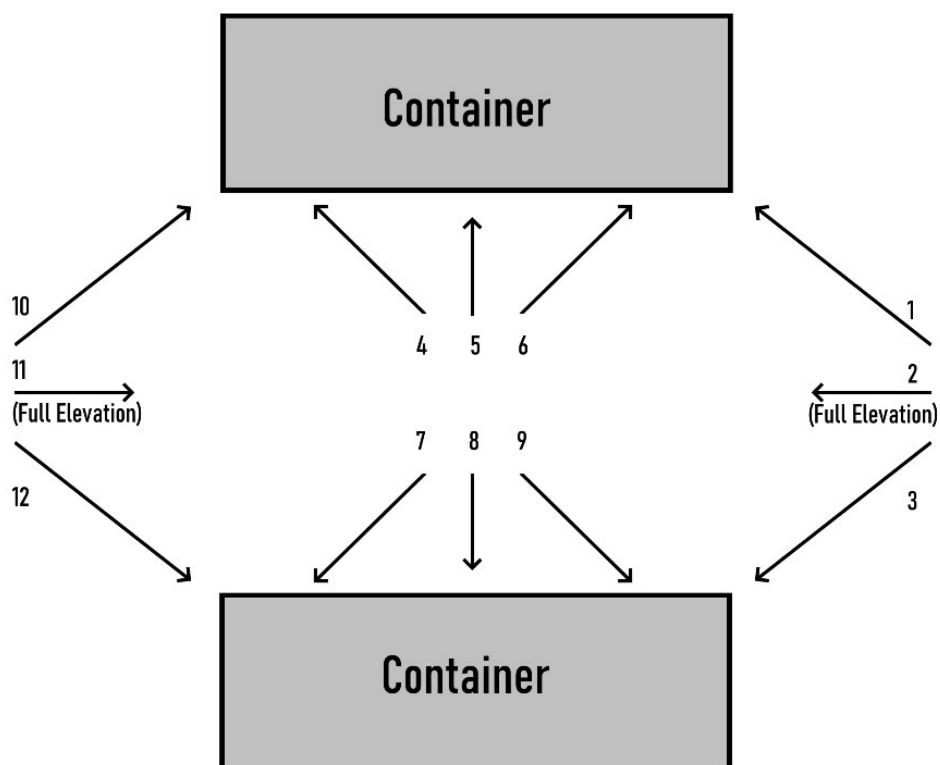
### Photo Angles

Please provide 12 high resolution photos from the below angles when submitting a **Maintenance Schedule**

| Maintenance Points | Container Dome | Completed By | Date Completed |
|---|---|---|---|
| Take photos to support your maintenance schedule document as per the photo angle examples on the following pages. Keep these photos on file for your records. These are not to be provided to Ezy Igloo unless requested by Ezy Igloo (in support of a warranty claim). | | | |
